Factors affecting the efficiency of repair to propped and unpropped bridge beams

P. S. Mangat* and F. J. O'Flaherty*

This paper presents the results of laboratory and field investigations of bridge beams repaired both under propped and unpropped conditions. In the laboratory, beams were repaired using hand-applied repairs. Repairs to beams in two highway bridges were carried out using both hand-applied and flowing repairs. The repair materials used were commercial products of wide-ranging properties (shrinkage, creep and elastic modulus). Both low stiffness repair materials of elastic modulus, E_{rm} , less than the substrate E_{sub} , and high stiffness repair materials ($E_{rm} > E_{sub}$) were used. The repairs were applied in the tensile zone of the beams. Strain distributions in the different phases of repair patches were monitored under service loading for a period of up to 240 weeks. The results show that high structural efficiency is achieved with repairs having $E_{rm} > E_{sub}$, other properties (shrinkage and creep) being within reasonable limits. Such repairs are less prone to restrained shrinkage cracking and show a capacity for load redistribution into the repair p

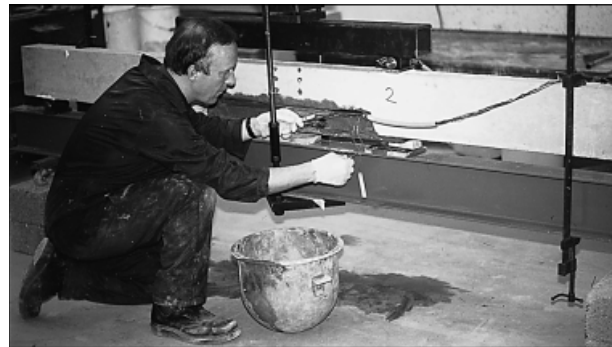
Fig. 2. Application of hand-applied repair, unpropped beam

unloaded (Table 1). Repairs to unpropped beams were applied by placing timber formwork on the soffit of the beam and supporting it with wedges built up from the top flange of the creep rig (see following subsection). This allowed the repair material to be inserted into the void from either side (vertical face) of the beam as shown in Fig. 2. Embedment gauges within the repair material were also inserted as the repair progressed (Fig. 2). Each repair material was mixed in accordance with the manufacturers' instructions. The material was hand-built to within 10 mm of the finished surface
